PROJECT **123A90 - HOLLANDSE KUST NOORD WIND PARK**
BLPH Project

COMMISSIONING DOSSIER (ONSHORE)

SYSTEM	25 Hydrogen Storage
SUBSYSTEM	25-01 Hydrogen Storage Vessel A (V-25001A)

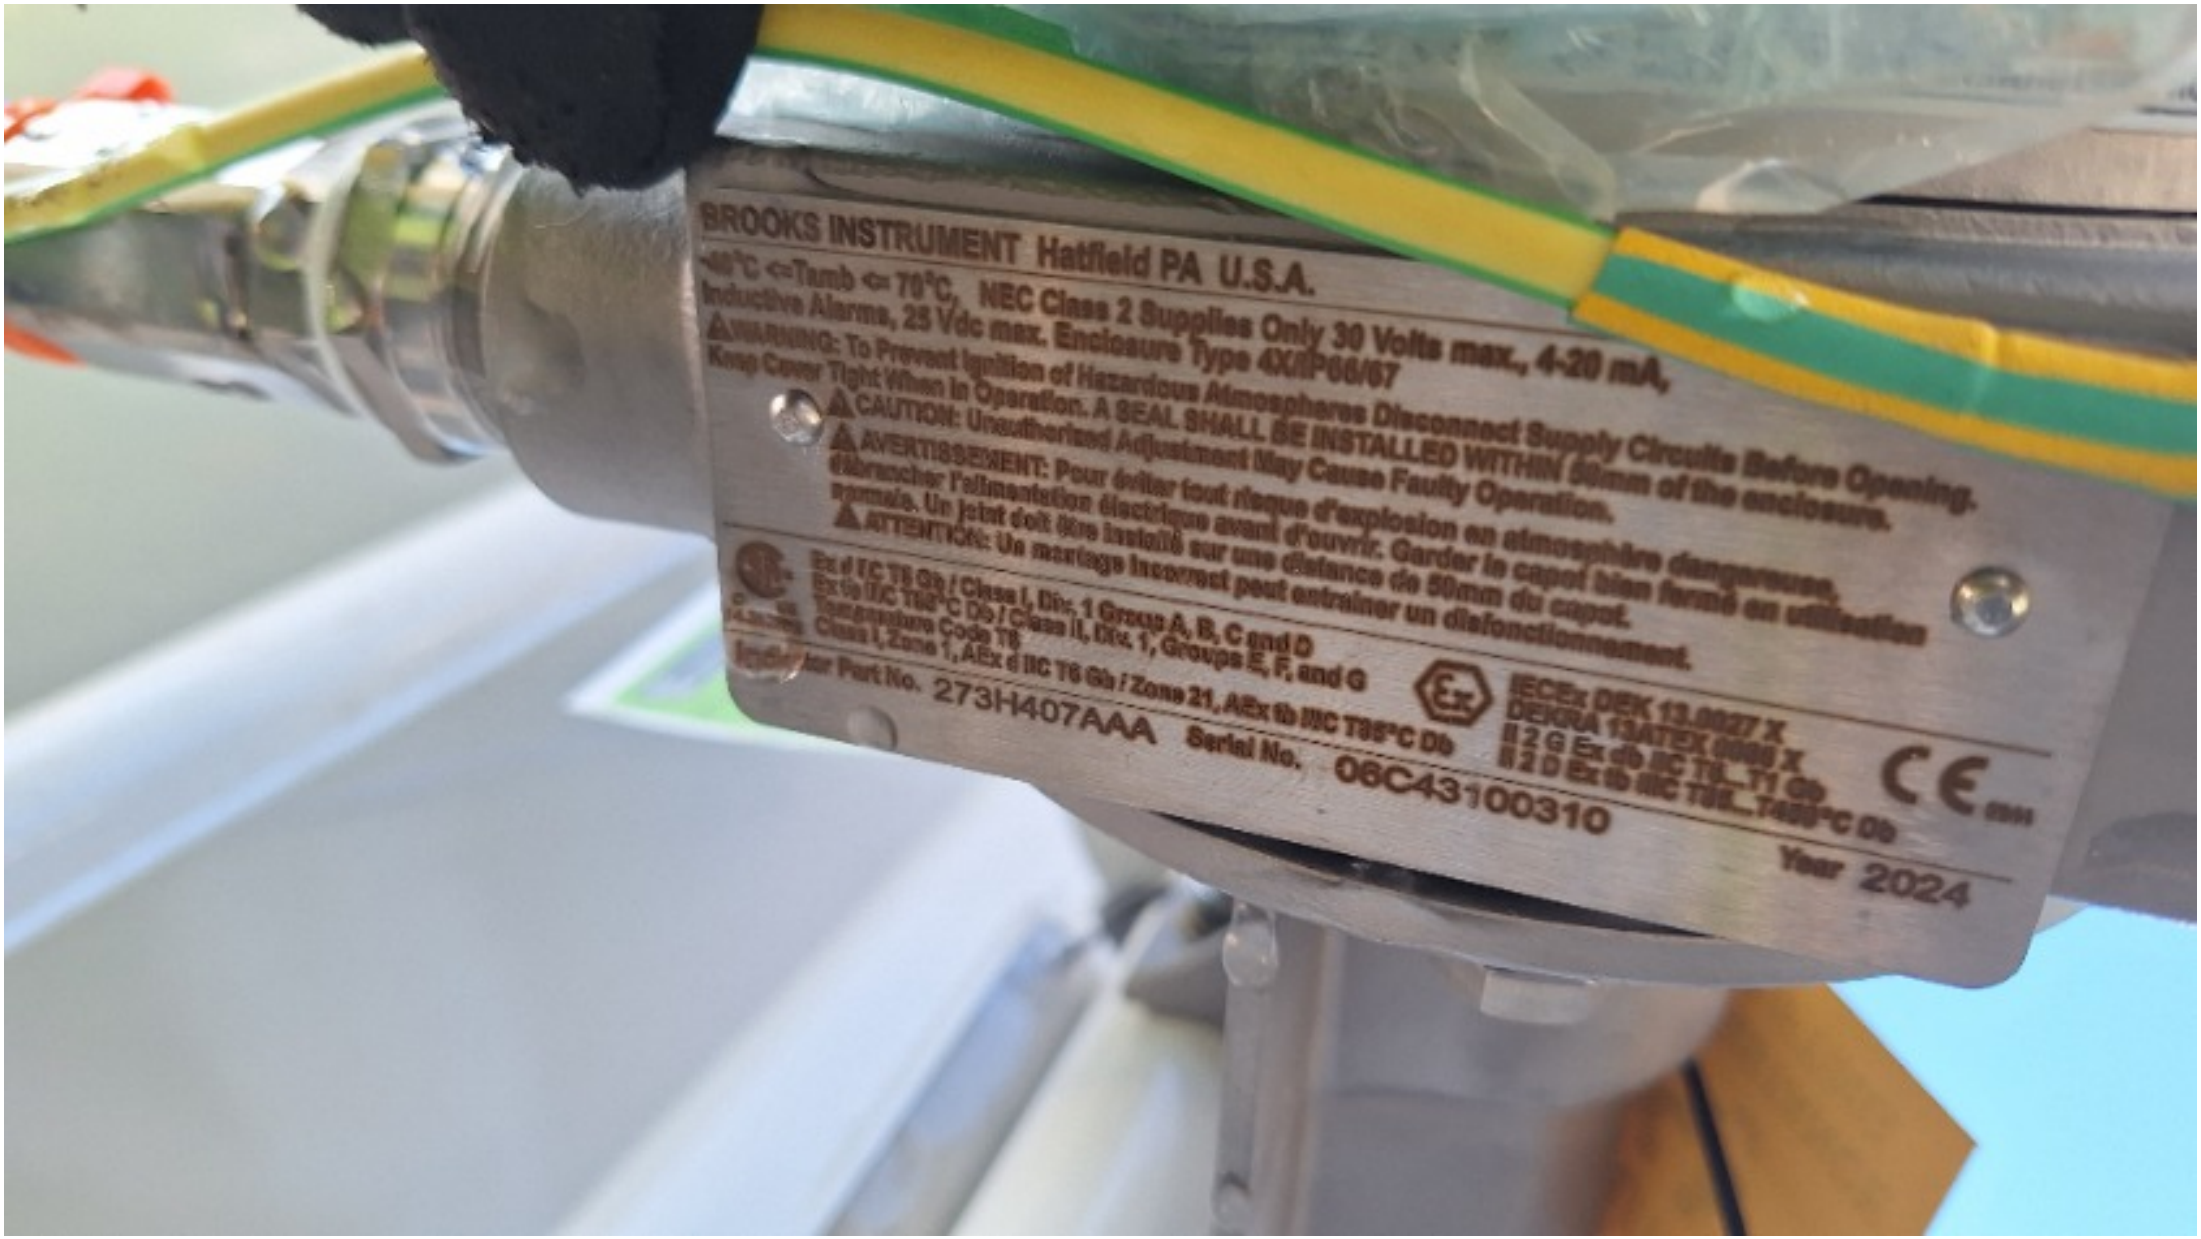
The plug is not installed according to the specifications. To be replaced with plug Ex-d/e IIC , (see 123A90-DDL-IN-HD-40079_Rev.02 sh. 29).

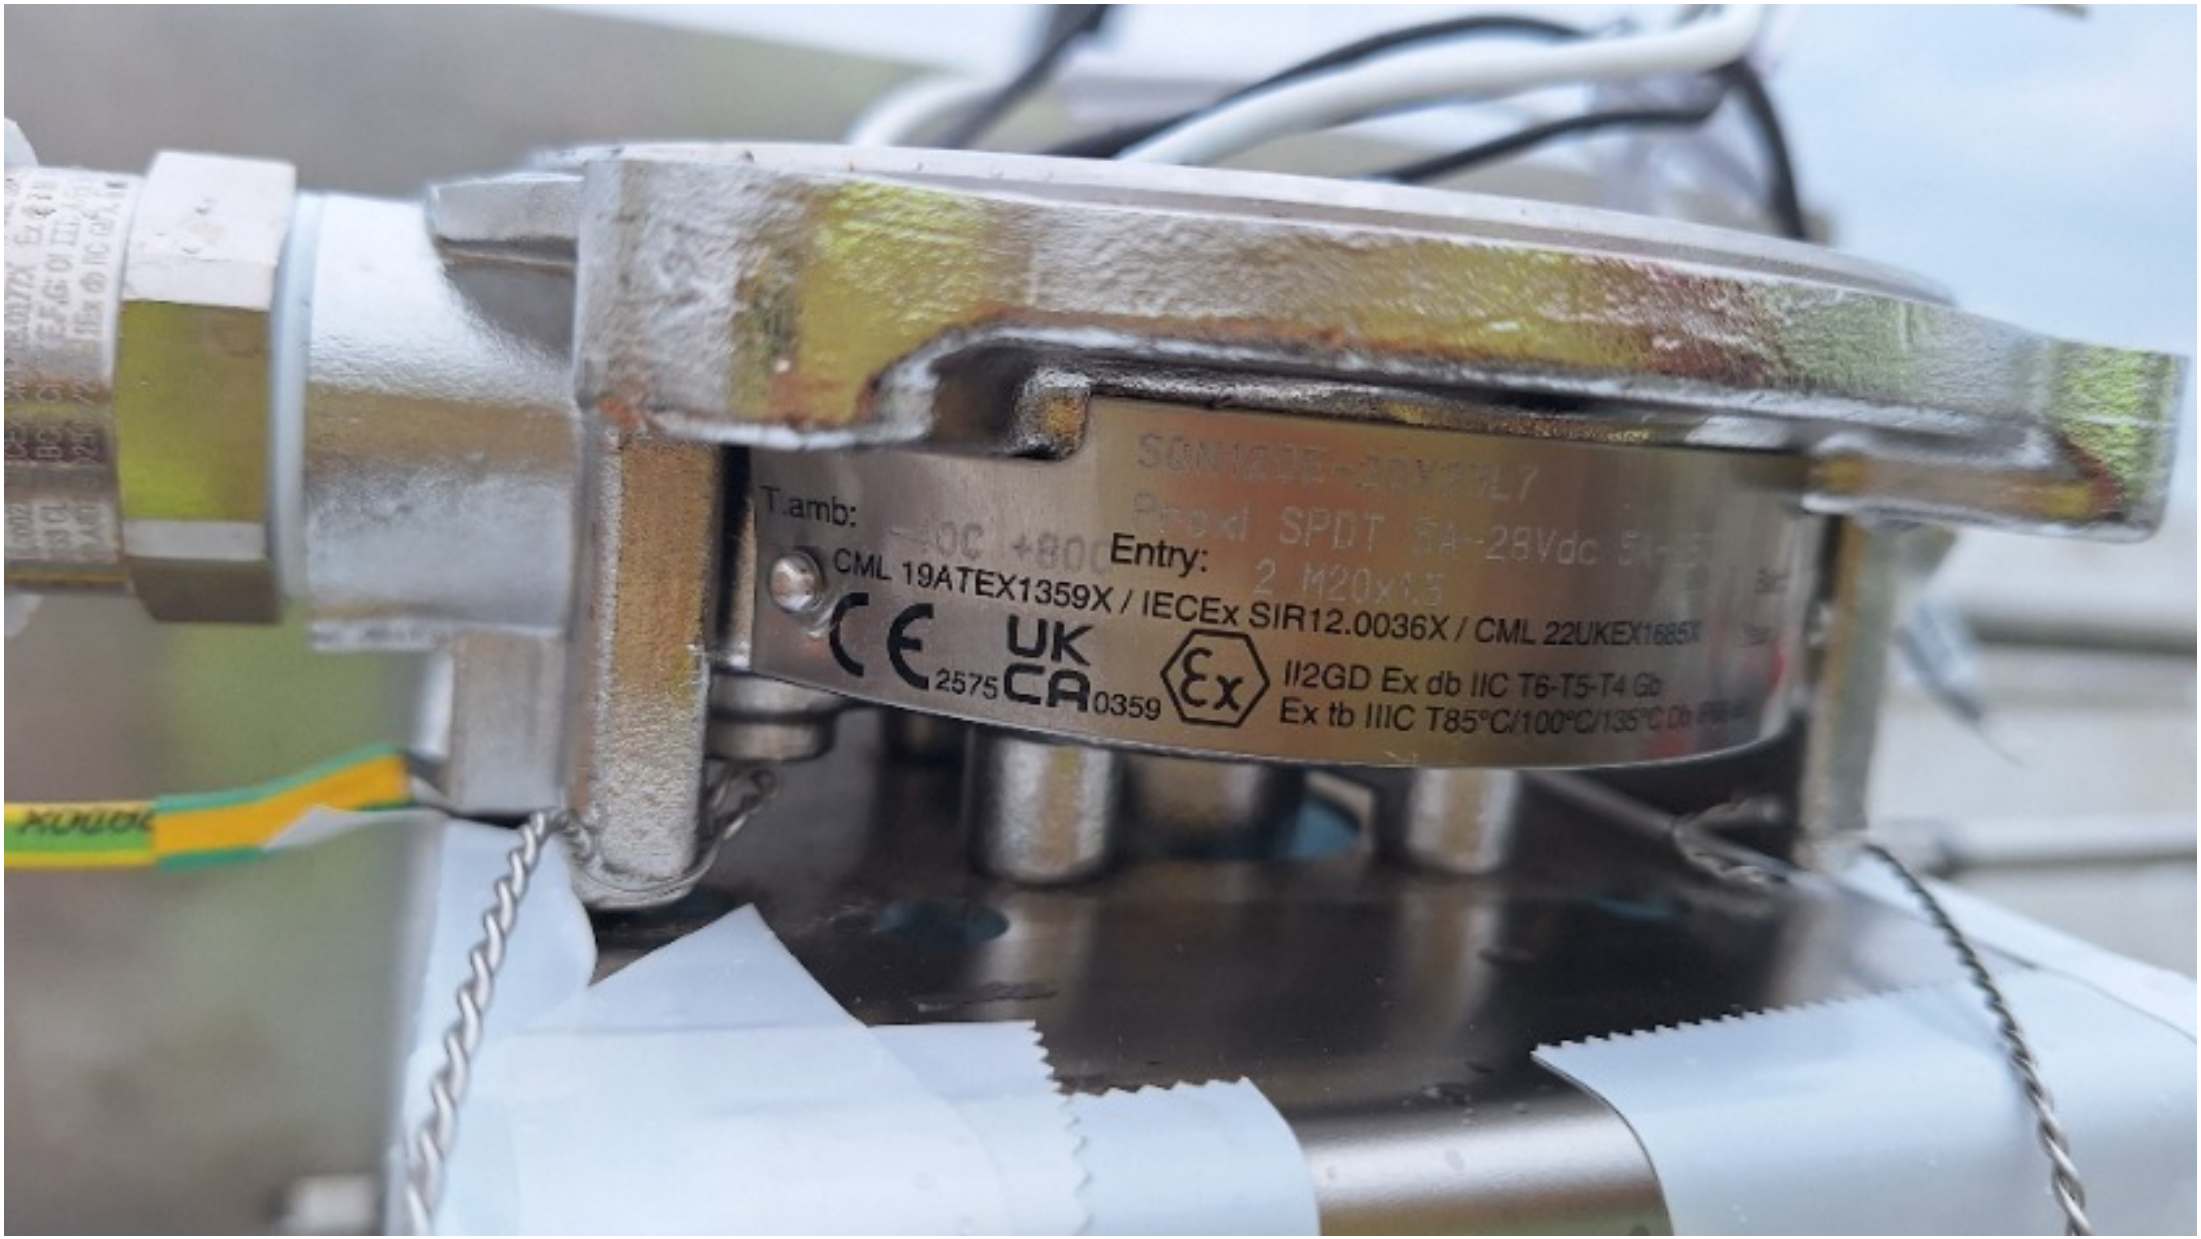
On ATEX register (123A90-DDL-LIS-20094 sheet 8) Manufacturer, Atex certificate, SN, Atex marking etc. are missing or wrong.

The ATEX Register issued by FLUITEK has been updated and now reflects the equipment actually installed on BLPH. Document 123A90-DDL-EL-LIS-20094 will endorse and confirm the information contained in the updated ATEX Register.
