PROJECT **123A90 - HOLLANDSE KUST NOORD WIND PARK**
BLPH Project

COMMISSIONING DOSSIER (ONSHORE)

SYSTEM	25 Hydrogen Storage
SUBSYSTEM	25-03 Hydrogen Storage Vessel C (V-25001C)

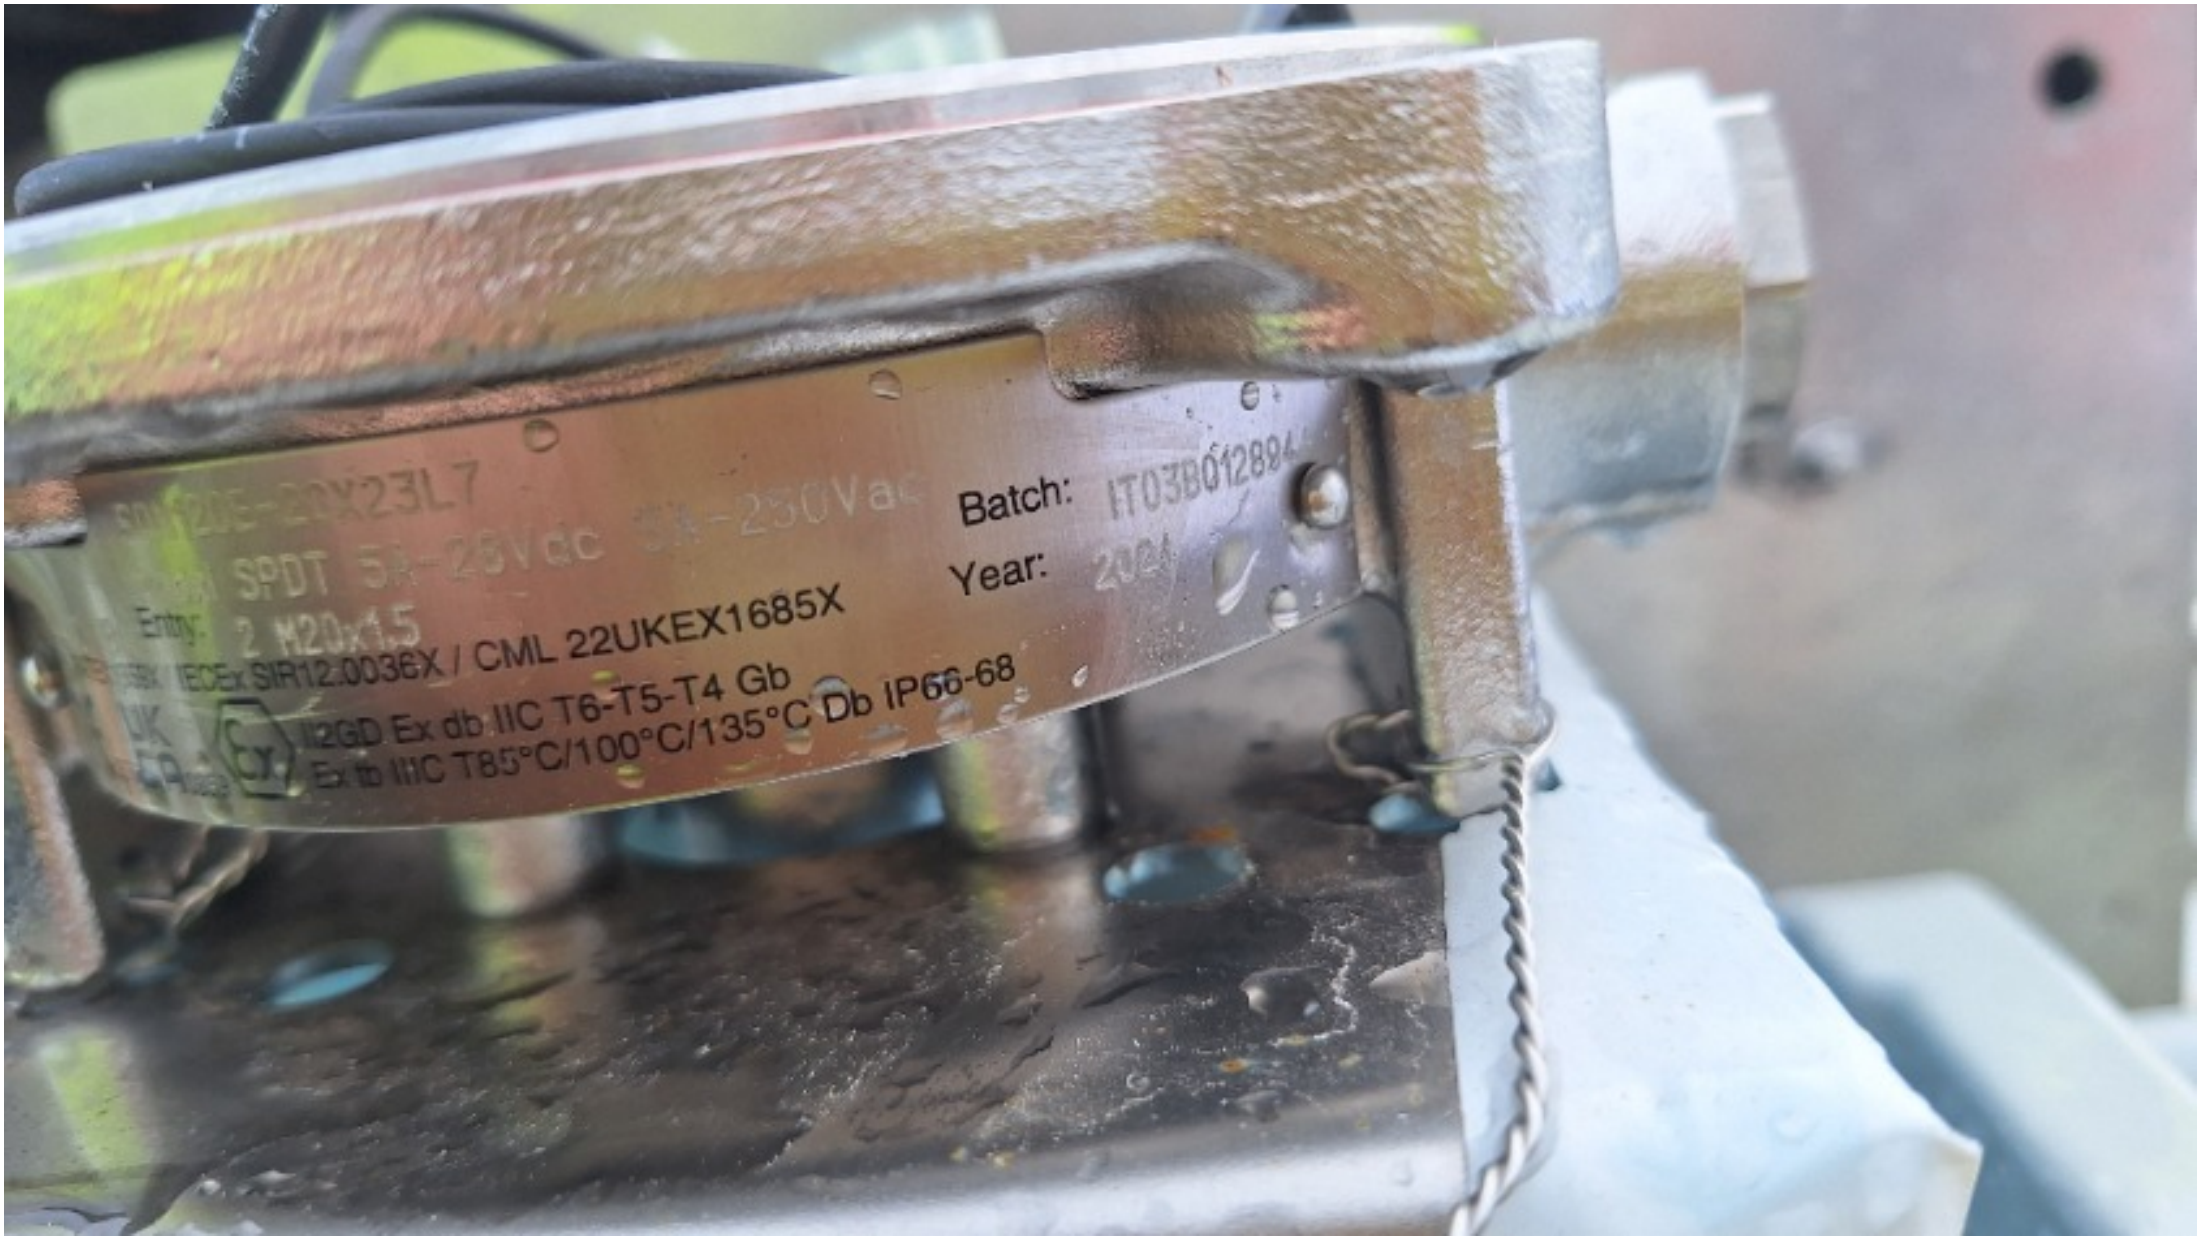
The ATEX Register issued by FLUITEK has been updated and now reflects the equipment actually installed on BLPH. Document 123A90-DDL-EL-LIS-20094 will endorse and confirm the information contained in the updated ATEX Register.

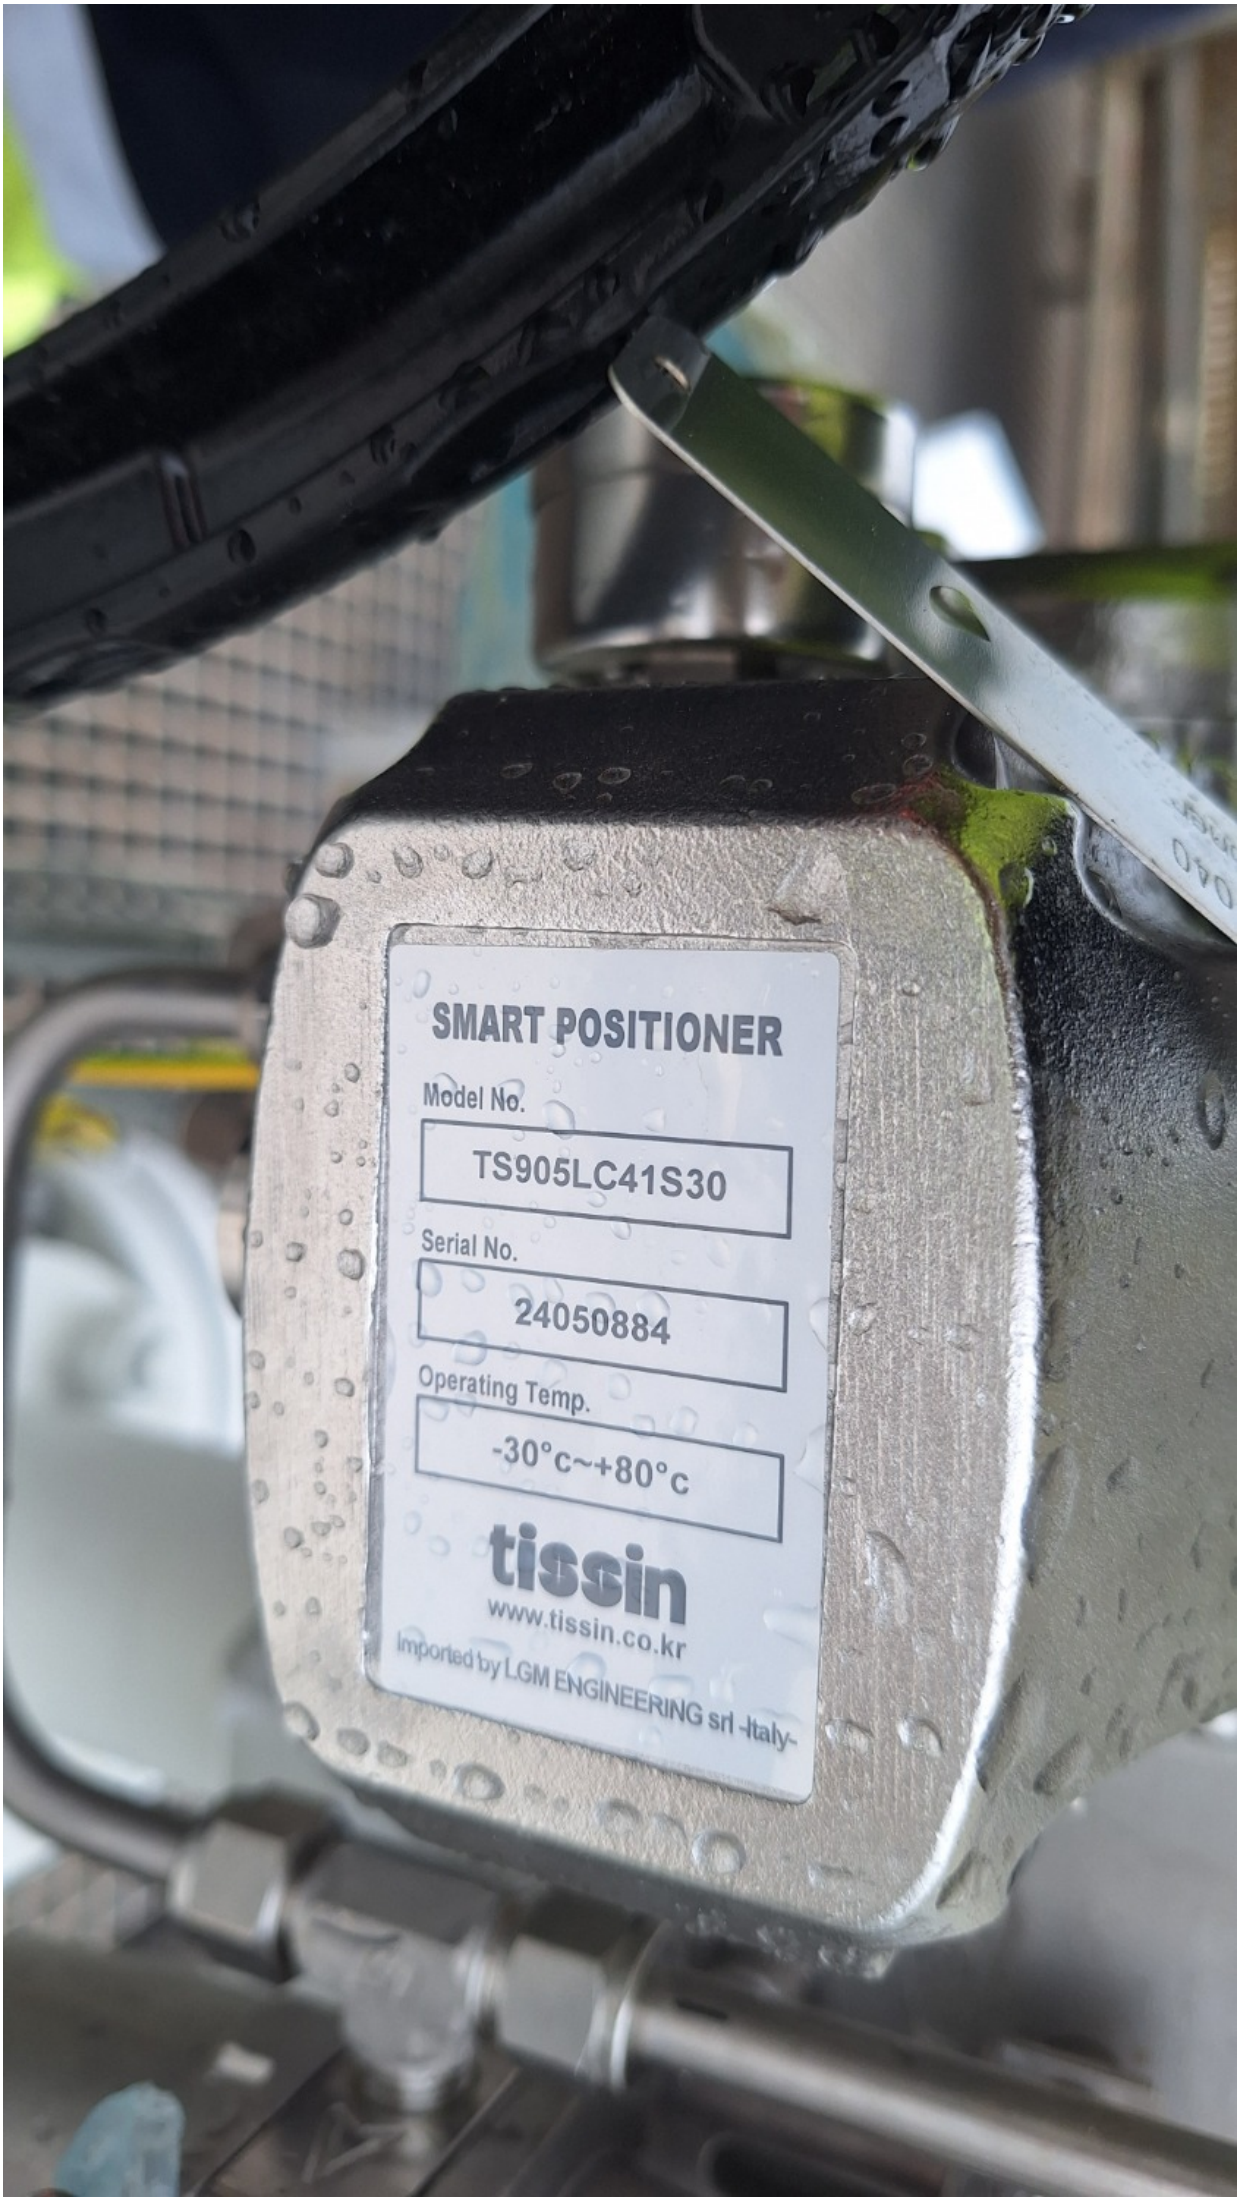
The visual indicator cover (limit switchZSHL) is damaged.

Damage only on the surface of the cover. Sealing function not compromised.

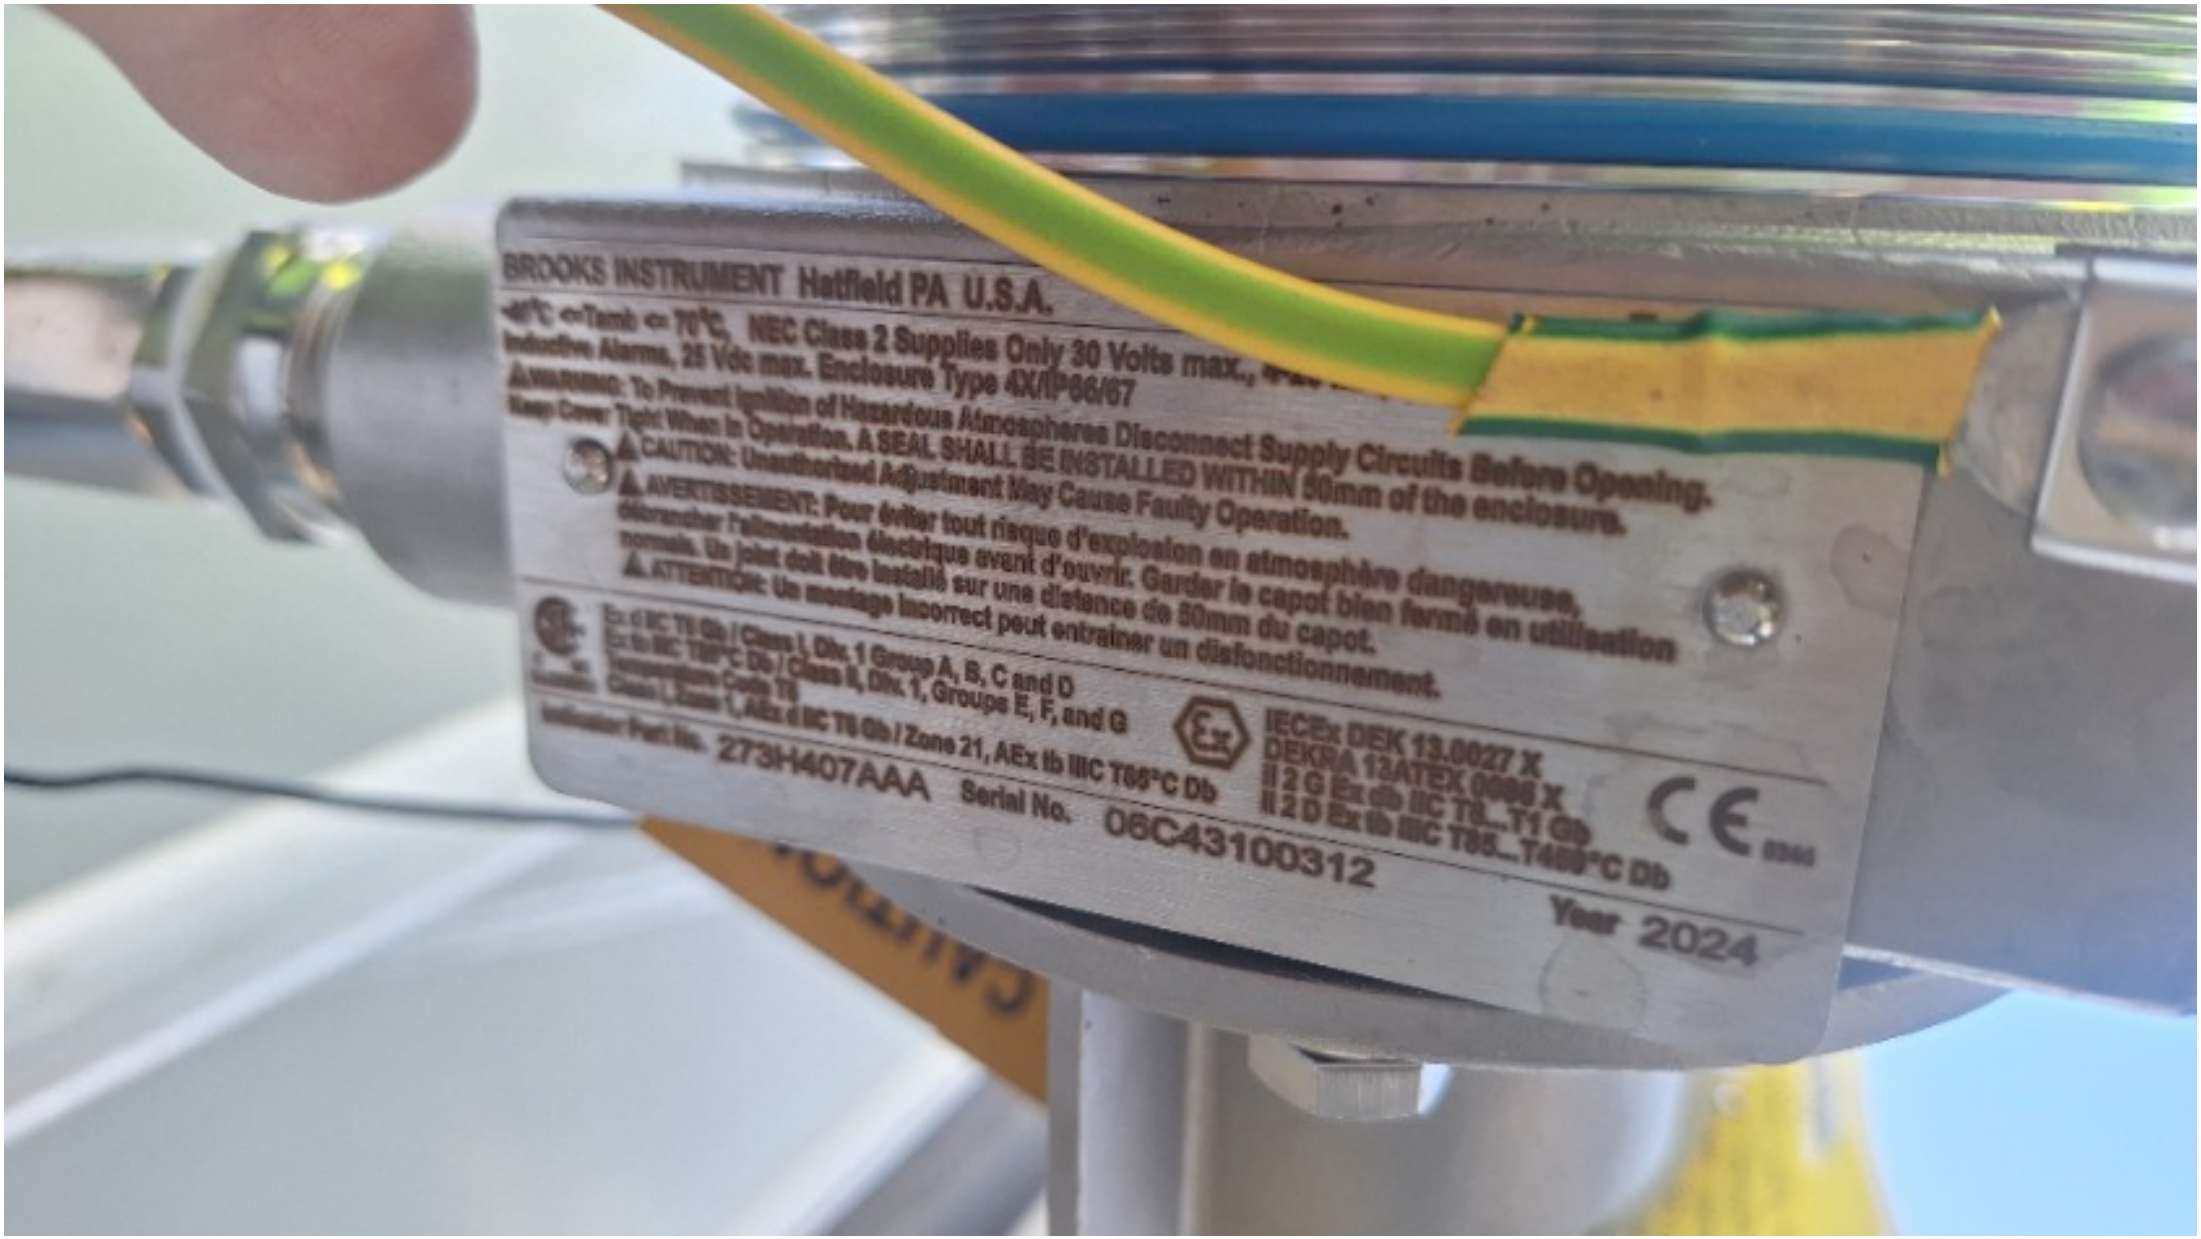
Slight discrepancy noticed after loop check with instrument in service. Instrument vendor shall be contacted to understand if the instrument must be re-calibrated or repaired.
