PROJECT **123A90 - HOLLANDSE KUST NOORD WIND PARK**
BLPH Project

COMMISSIONING DOSSIER (ONSHORE)

SYSTEM	25 Hydrogen Storage
SUBSYSTEM	25-06 Hydrogen Storage Vessel F (V-25001F)

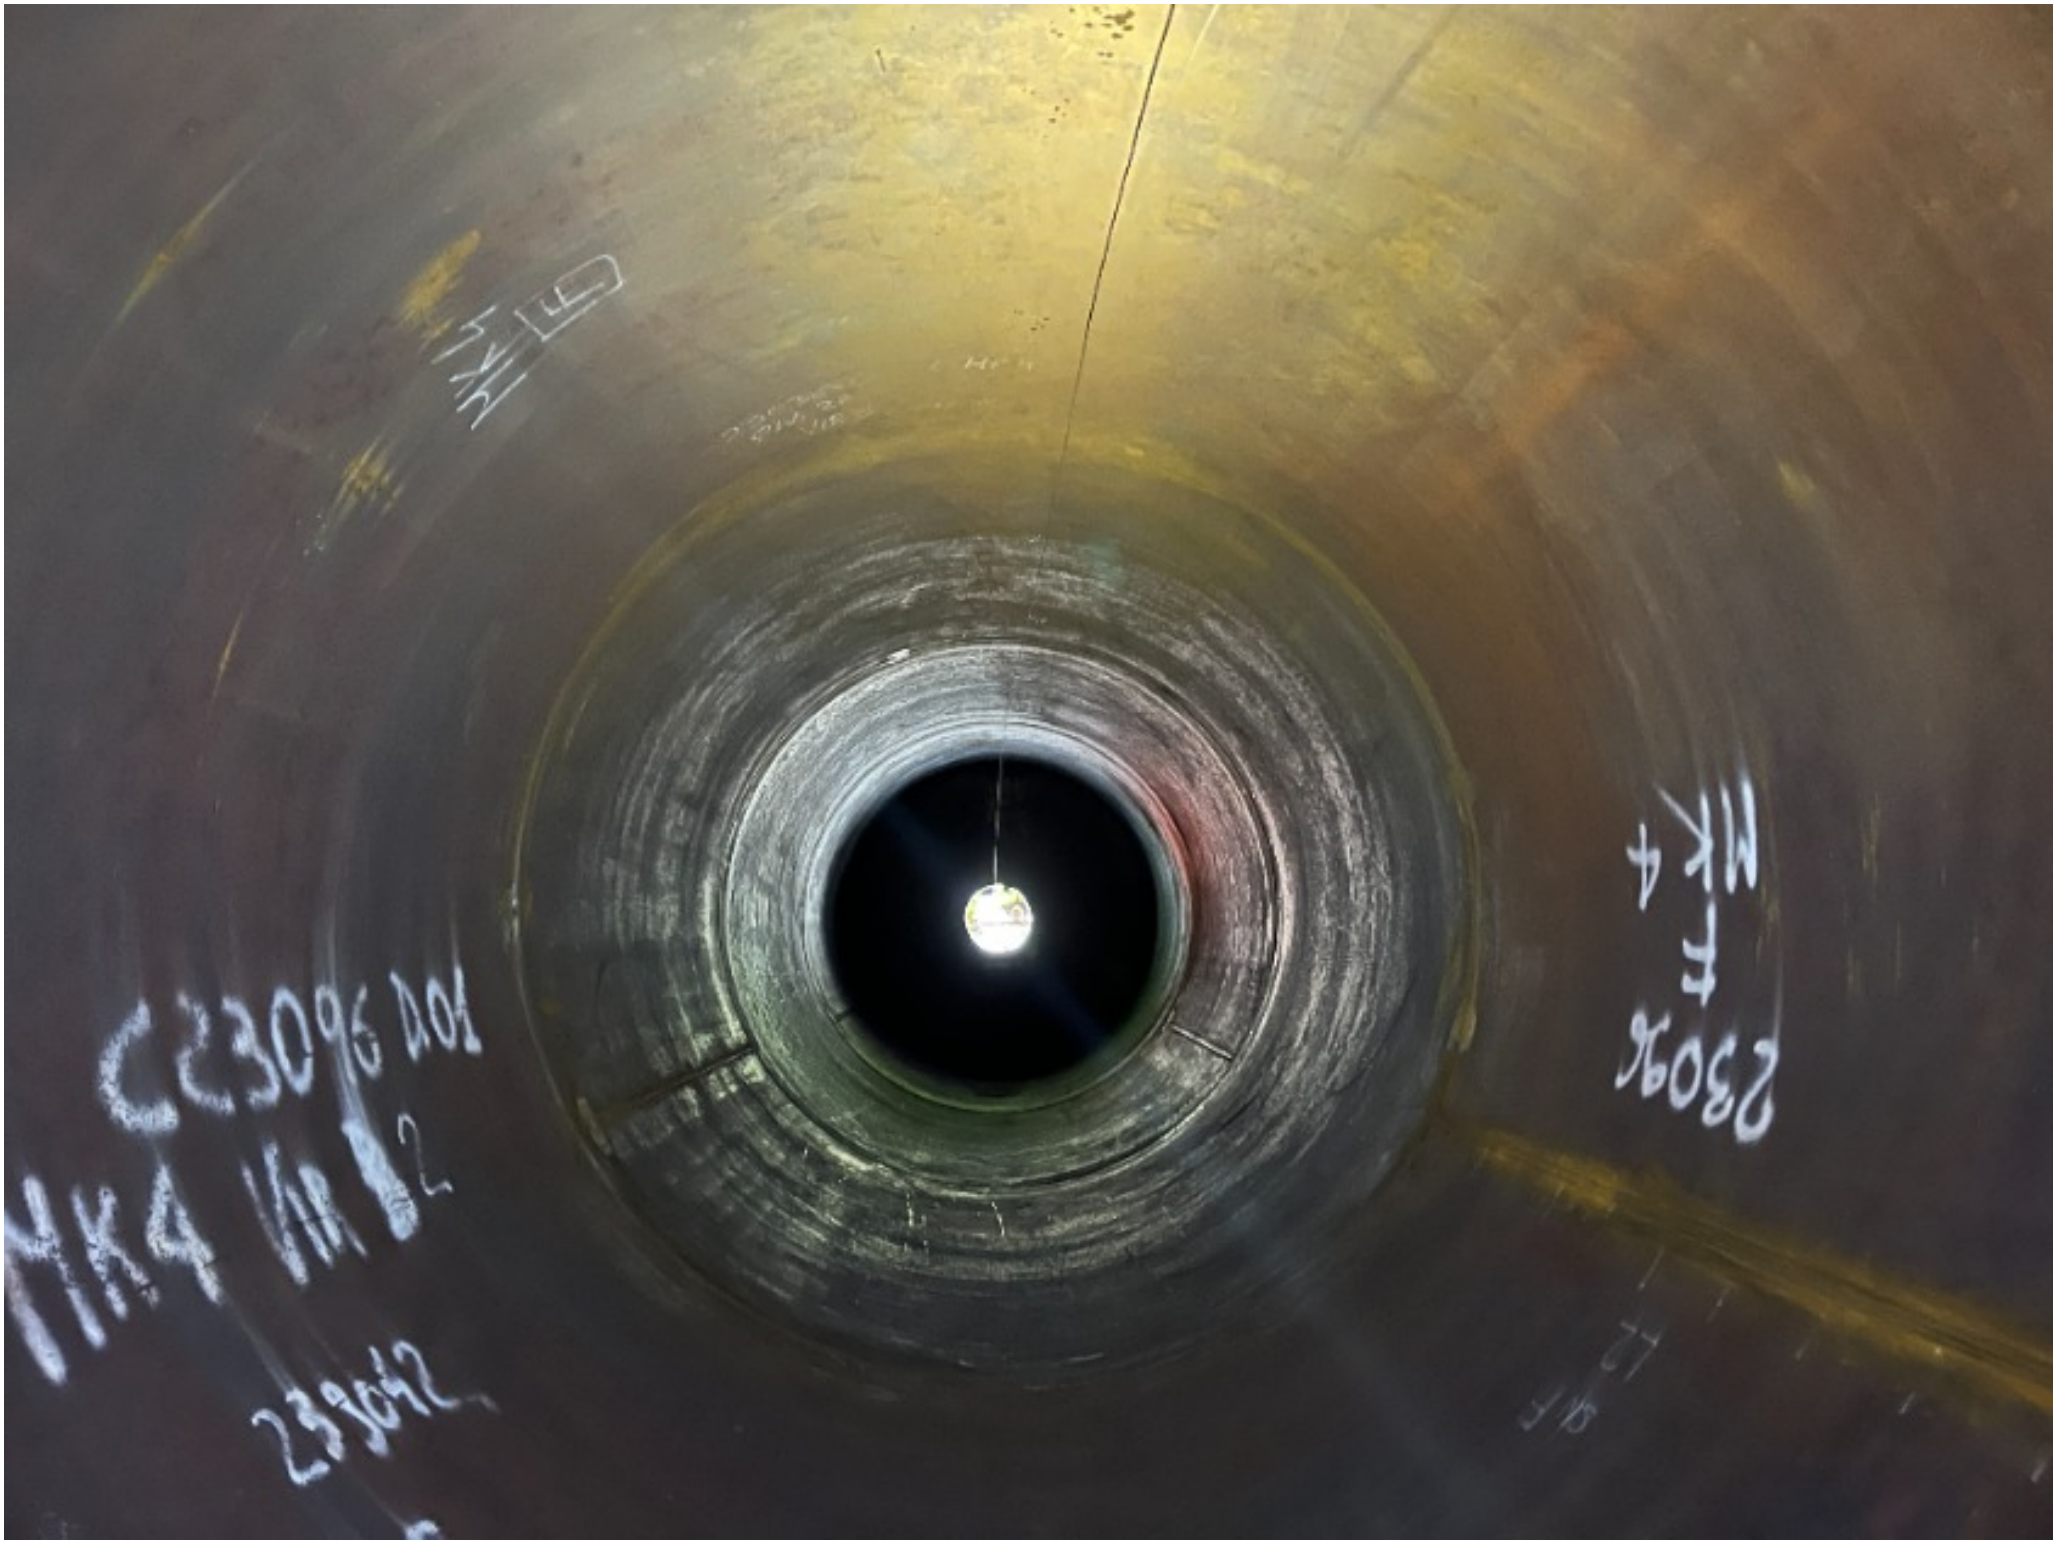
Reviewed the video of the internal inspection together with the Ballard Site Representative.
