PROJECT **123A90 - HOLLANDSE KUST NOORD WIND PARK**
BLPH Project

COMMISSIONING DOSSIER (ONSHORE)

SYSTEM	83 Main Power Distribution Low Voltage 440 V
SUBSYSTEM	83-36 Emergency Lighting Lower Deck

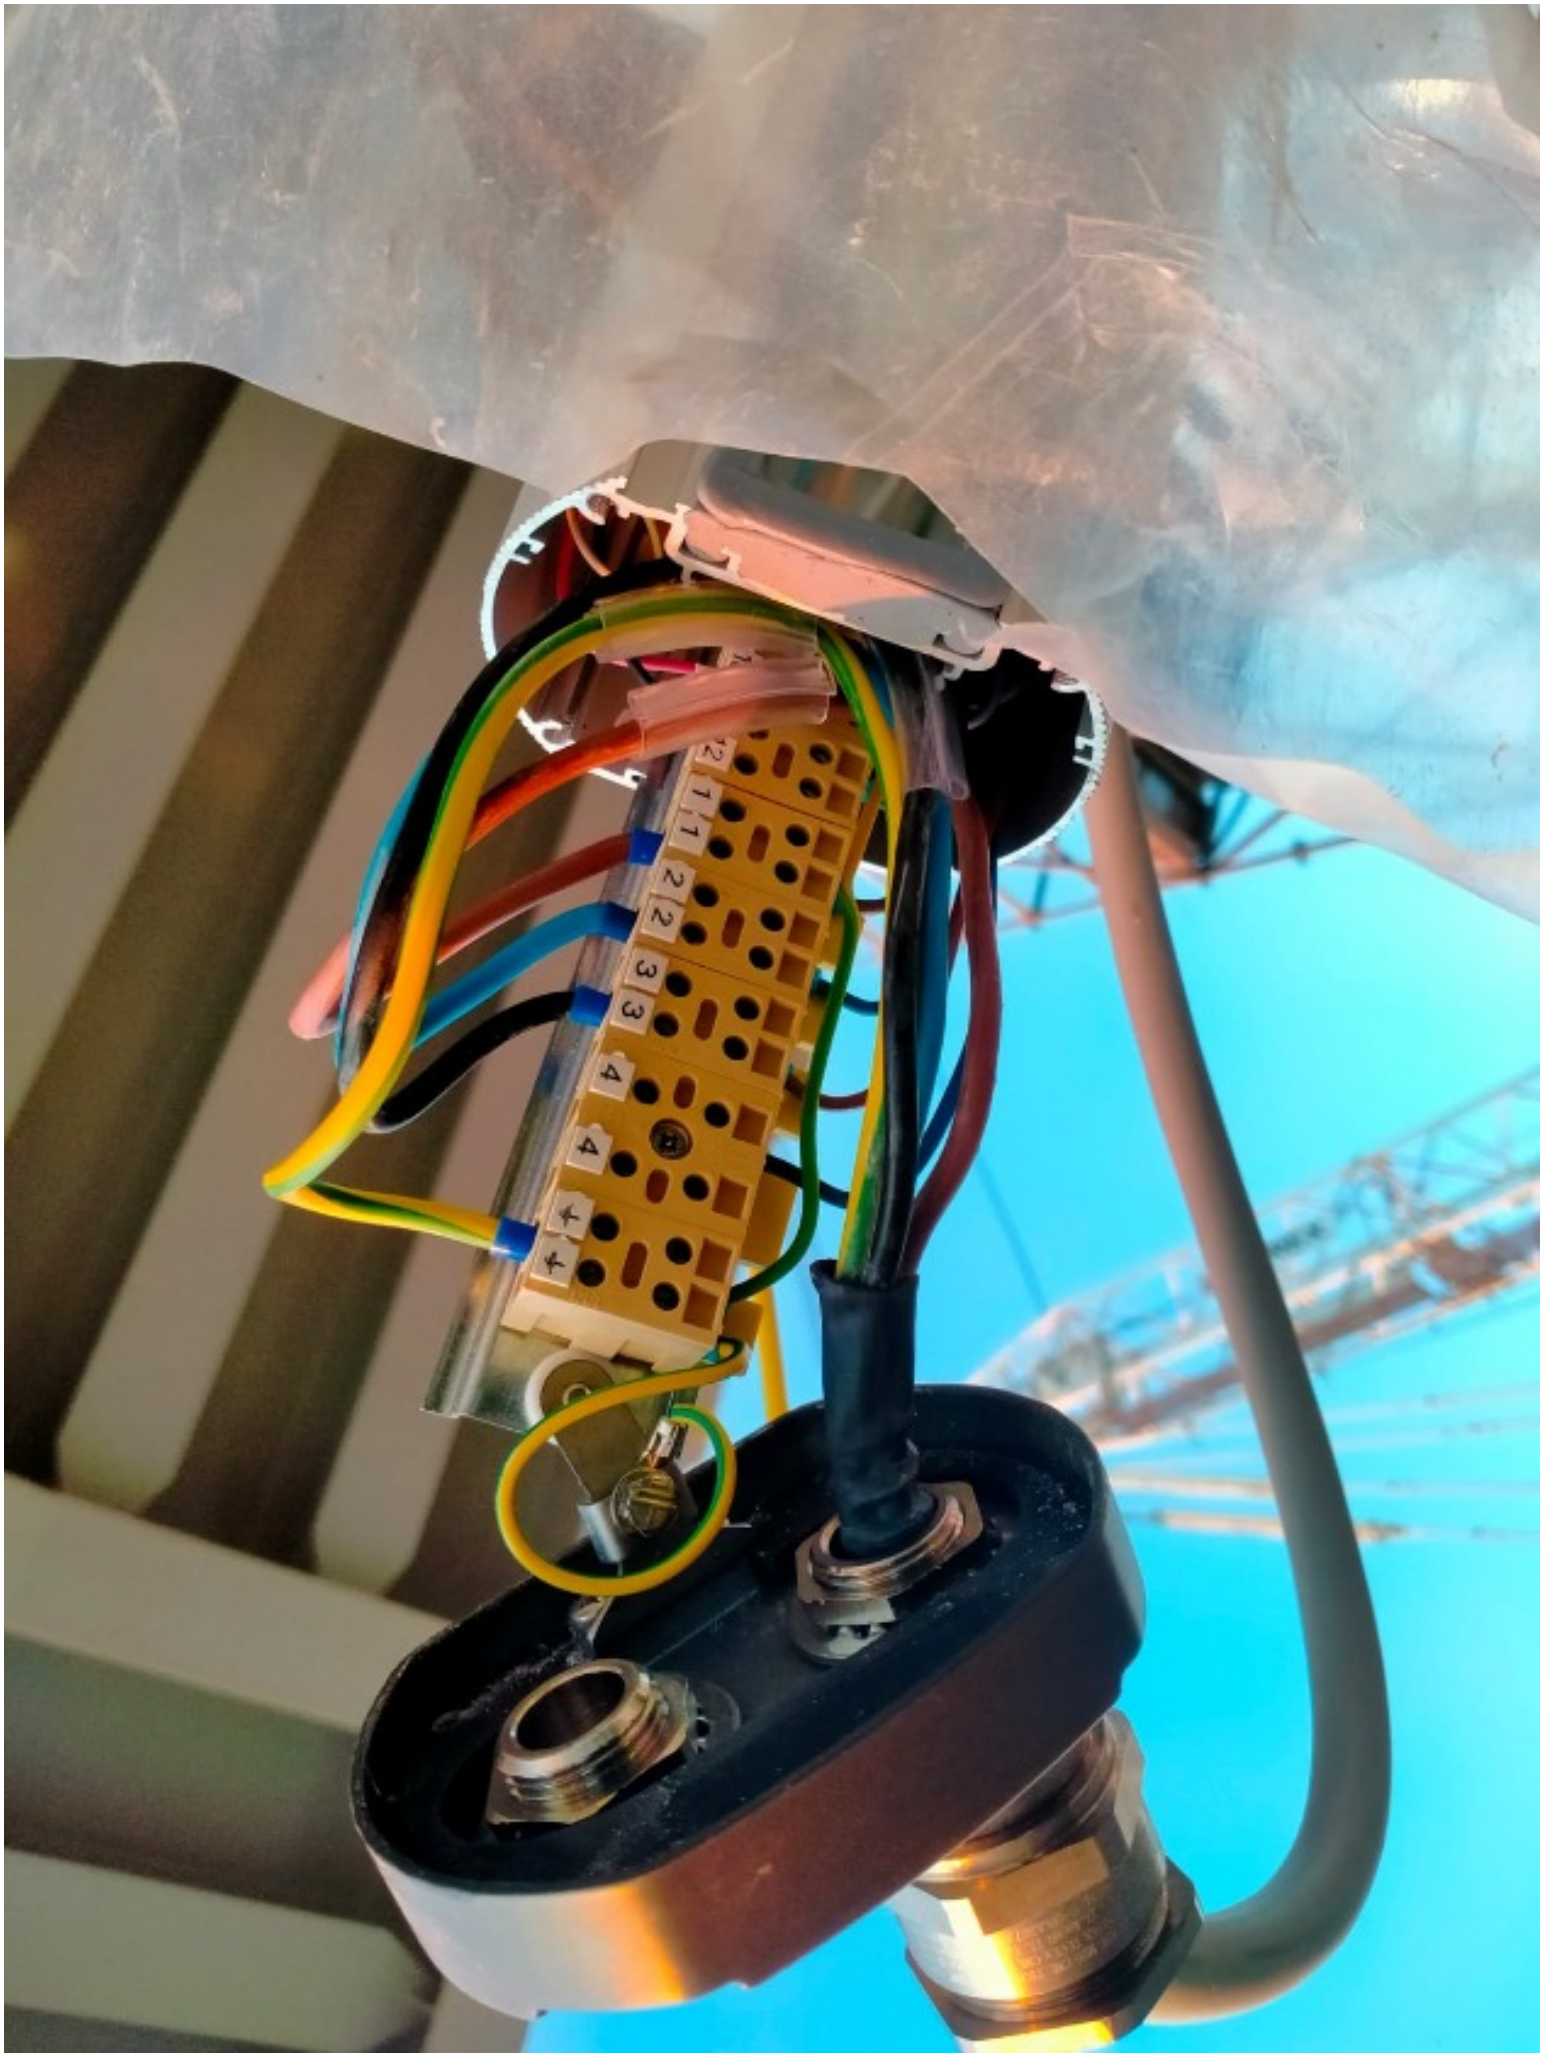
Missing jumper between terminations 2 and 4 as per 123A90-DDL-EL-DG-20125

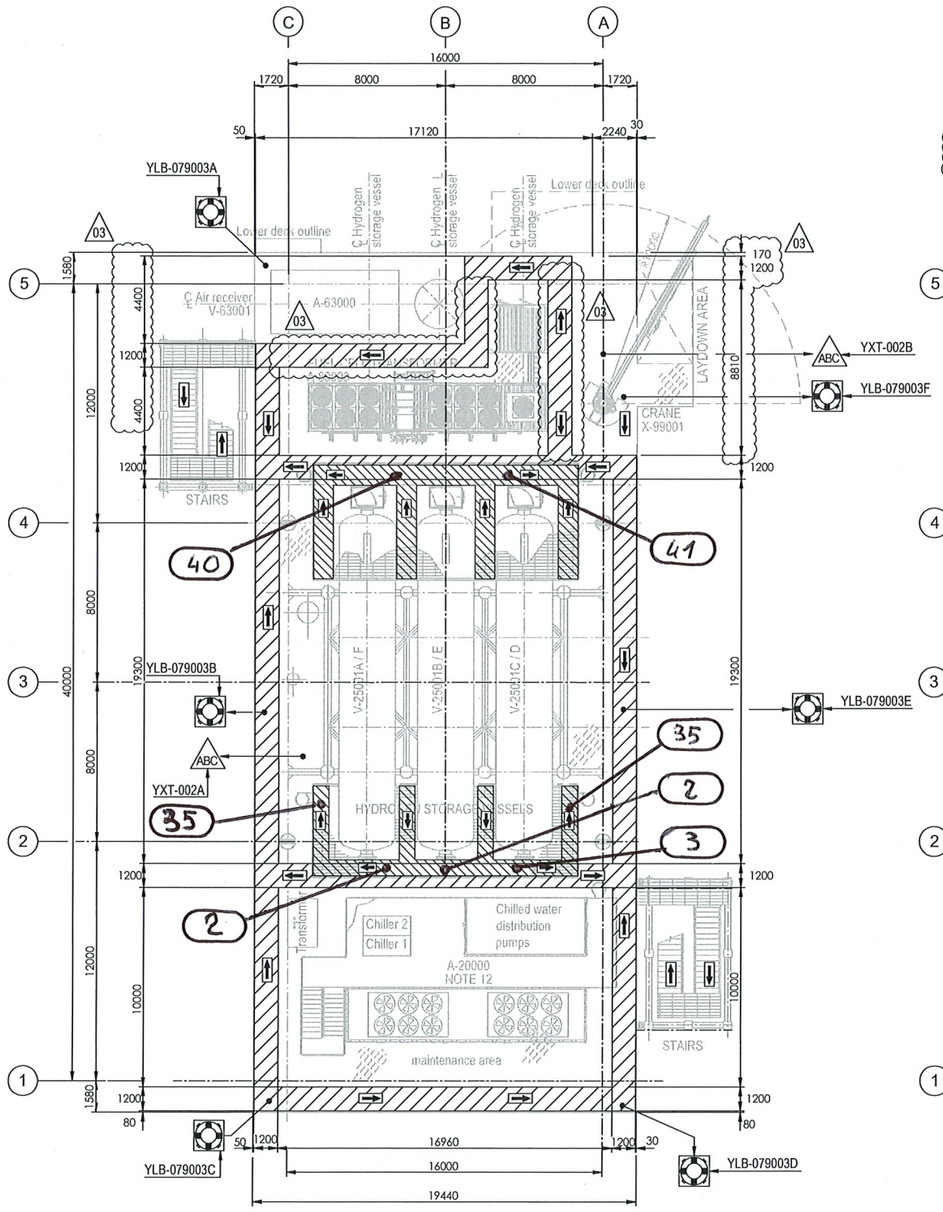
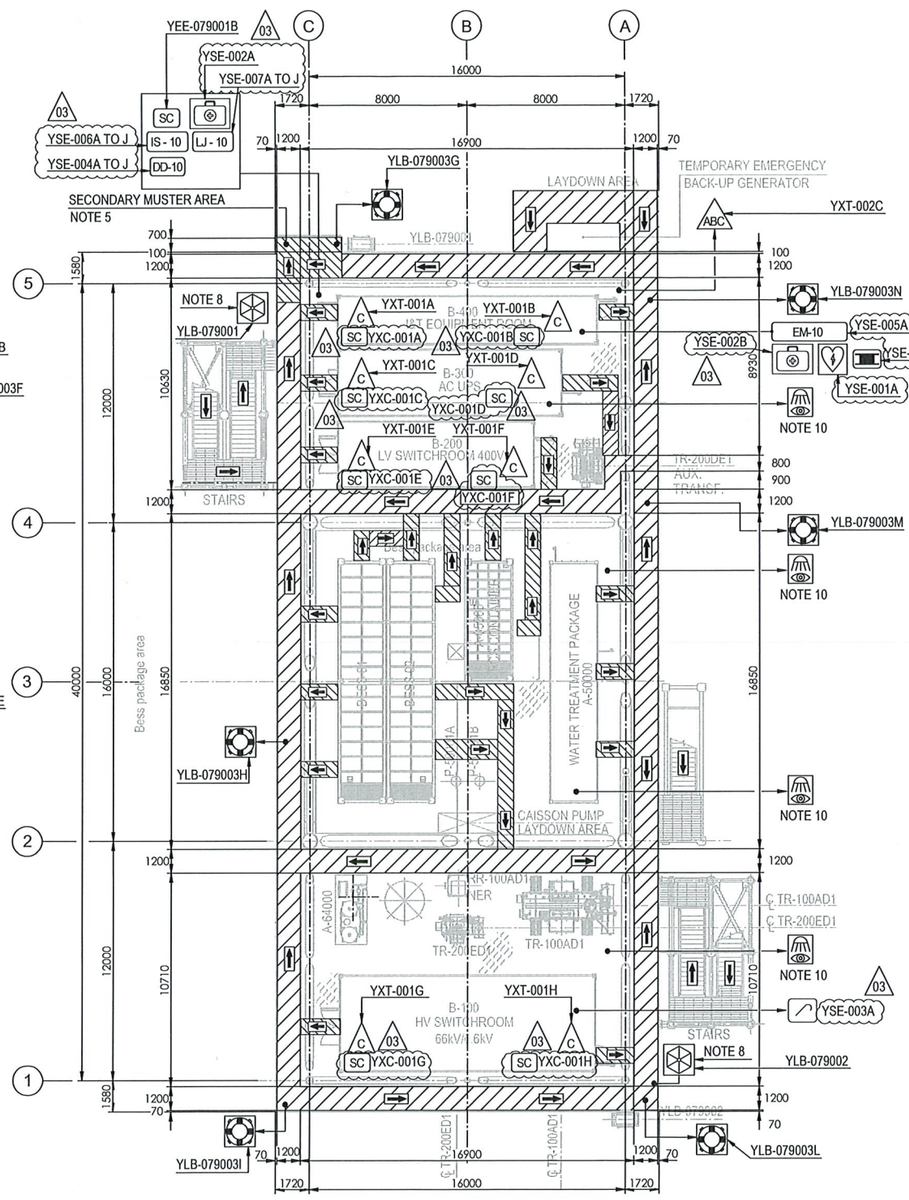
DRAWING NO. 123A90-DDL-SAF-DL-30025 REV. 03

Comments: WITH REFERENCE TO NOTES 3. & 4. THE LUX MEASUREMENTS IN EMERGENCY SCENARIO FOR THE EMBARKATION AREA, WALKWAYS AND ESCAPE ROUTES HAVE PROVEN A POSITIVE RESULT. ALL MEASUREMENTS TAKEN AT 0.00m ELEVATION.
