PROJECT **123A90 - HOLLANDSE KUST NOORD WIND PARK**
BLPH Project

COMMISSIONING DOSSIER (ONSHORE)

SYSTEM	83 Main Power Distribution Low Voltage 440 V
SUBSYSTEM	83-41 Normal Lighting Lower Deck

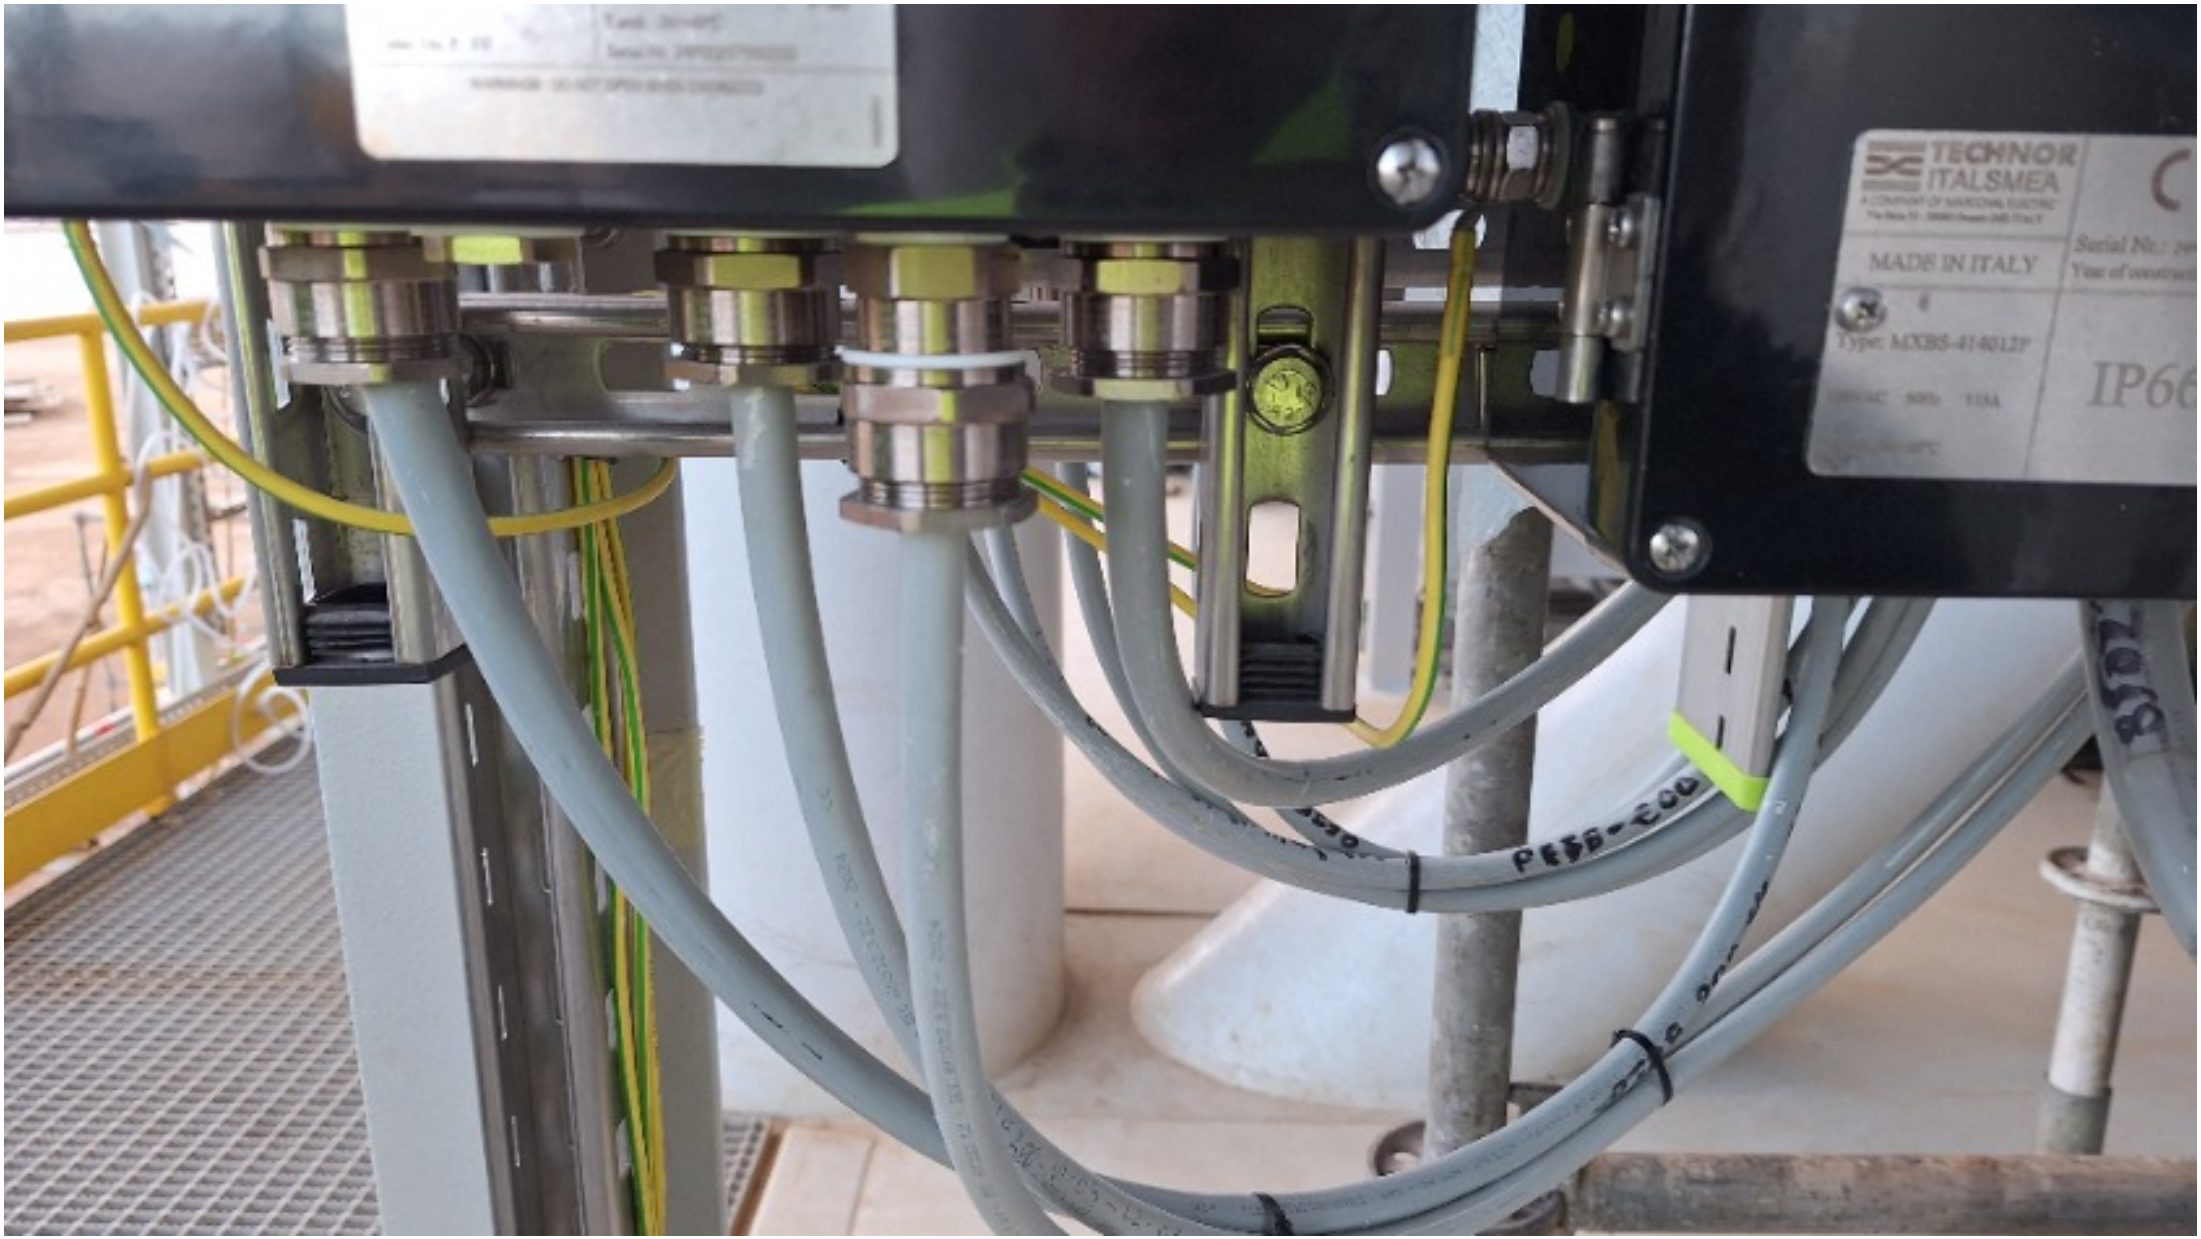
Missing cable tag SS , near the EJB-200N1-03-L2-04 / EJB-200N1-03-L2-05
